Addendum on Structural Damages (August 2016)

This addendum to the paper to be published at the 16th World Conference on Earthquake Engineering provides further descriptions on structural damages. **A FINAL REPORT including all updated observations and analyses will be published during the fourth quarter of 2016.**

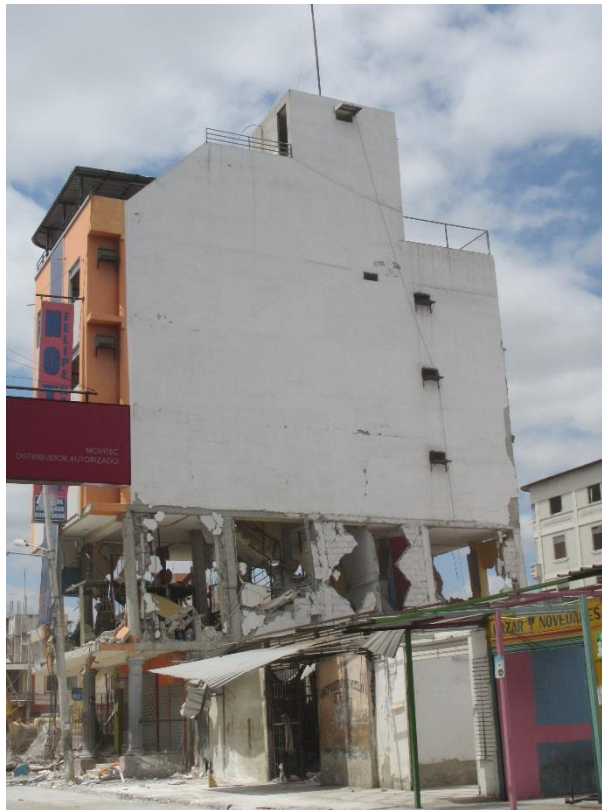
- Much of the observed earthquake damage was in the non-structural elements, mainly the fired clay brick or concrete block masonry infill walls. The masonry infill walls experienced both in-plane and out-of-plane failures (see Figure 5);

- Broadly, structural damage and failures were caused by soft storeys, shear and flexural failure of concrete columns, and localised damage due to pounding.

Figure 5 – Structural and non-structural damage

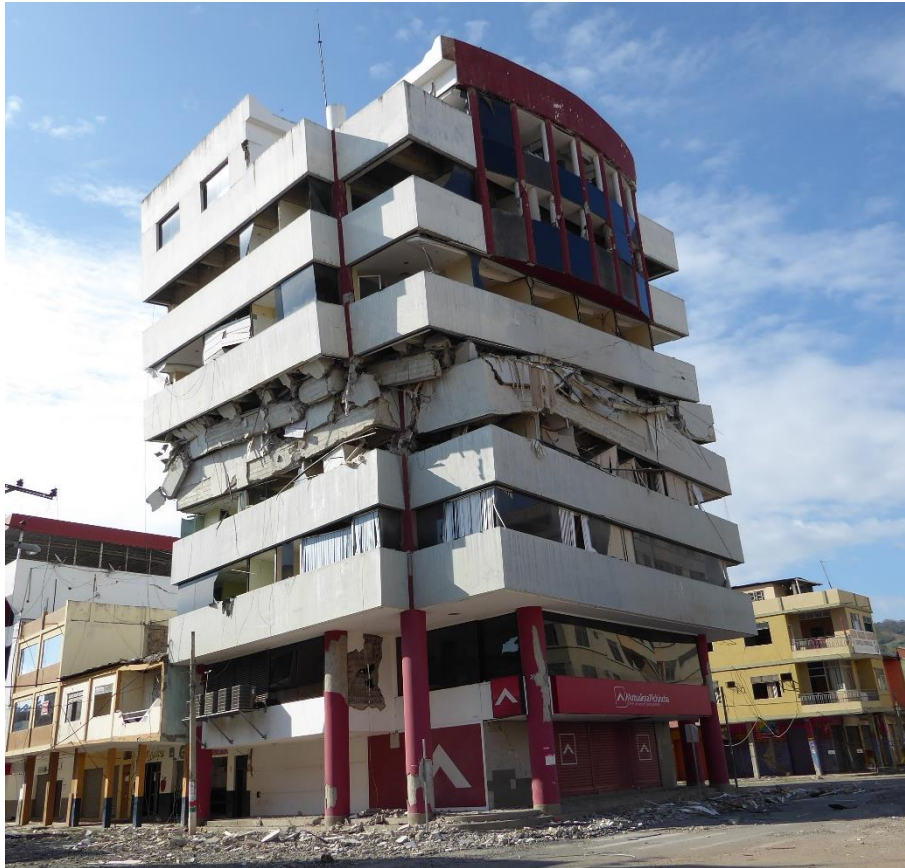
- Building typologies were mostly RC frame with masonry infill, with some *quincha* and timber frame buildings.
 - Structural damage varied considerably. Most RC buildings over three storeys experienced some level of damage, normally failures in masonry walls, however severe partial collapses were also seen (Figure 6).

Figure 6 – Upper floor soft storey collapse on two floors in Portoviejo

This failure occurs when a floor is weaker in strength or less stiff than the adjacent storeys, resulting in damage concentration at this floor level, which can exceed the capacity and result in collapse of that floor (Figure 6). This form of collapse was seen in a number of buildings: interestingly weak or soft storey failures were rarely observed at ground floor level, but instead at an upper level (e.g. Figure 6).

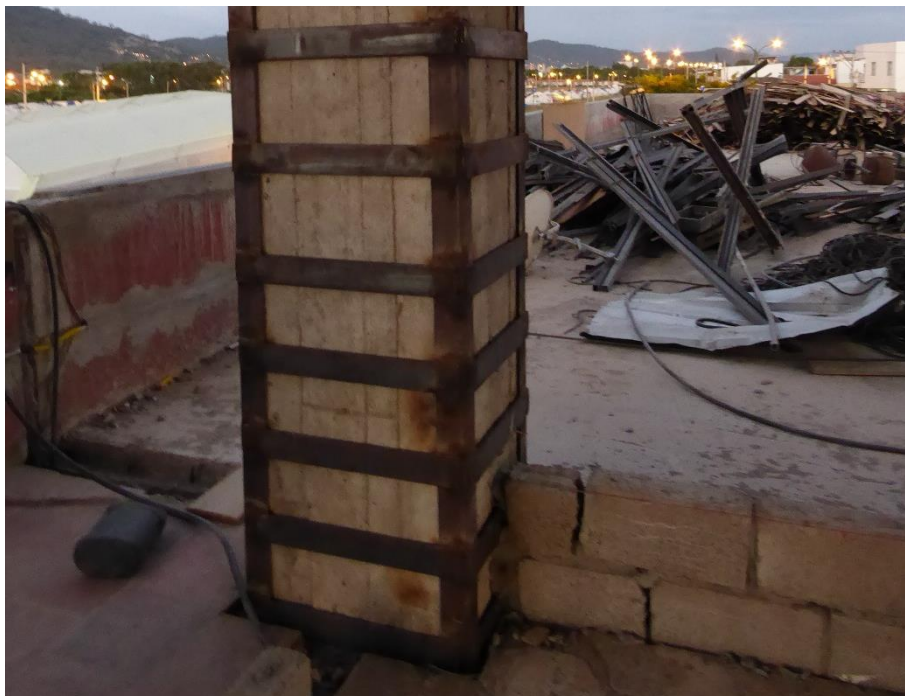
Figure 7 – Site welded steel plates for column strengthening in Portoviejo airport

- Airport building:
 - Column strengthening was seen to the upper floor columns in the airport building (Figure 7). The remedial work consisted of four steel angles placed

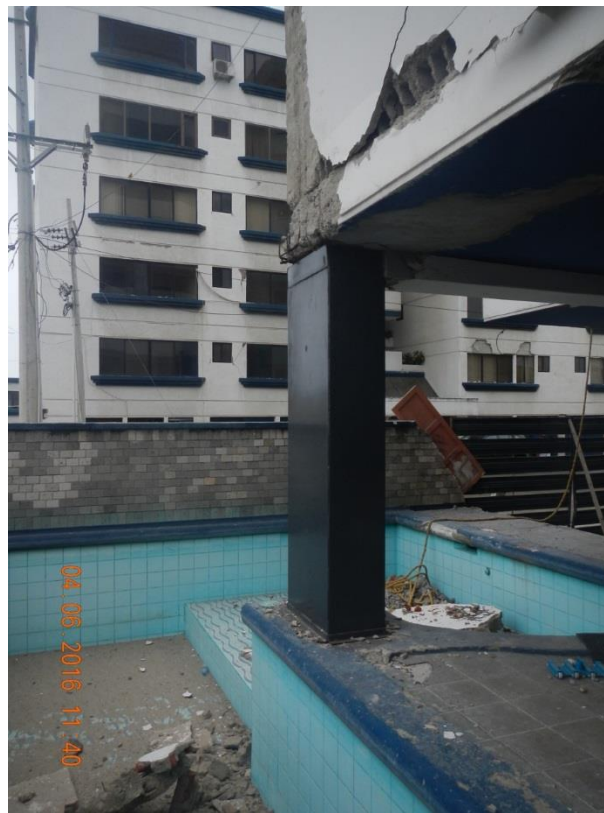
- Some structural damage was observed.
 - Interestingly, the building was undergoing a major strengthening programme, with steel plates add to encase the ground floor columns only completed a few days prior to the 16 April earthquake (Figure 8).

Figure 8 – Steel casing installed around ground floor columns just days before the 16 April 2016 earthquake

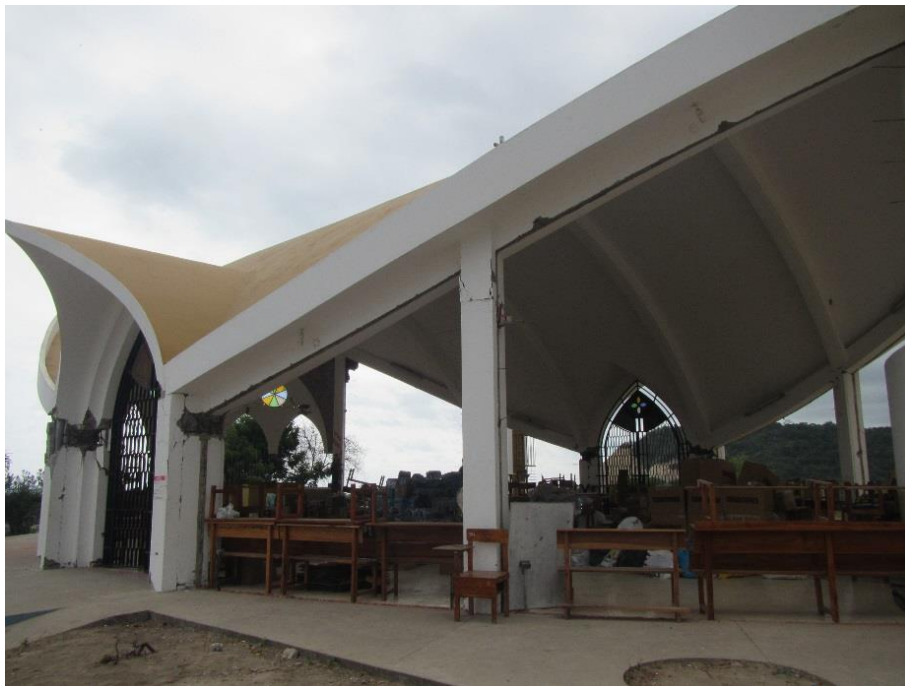
- Survey of Catholic church in Canoa (Figure 9):
 - Both structural and non-structural damage was observed in a Catholic church in Canoa.
 - Structural damage was found at the top of most of the columns, with most damage being concentrated in the shorter columns. The shorter columns were stiffer, therefore attracted more lateral loads than the taller columns.

Figure 9 – Structural damage of Church in Canoa.

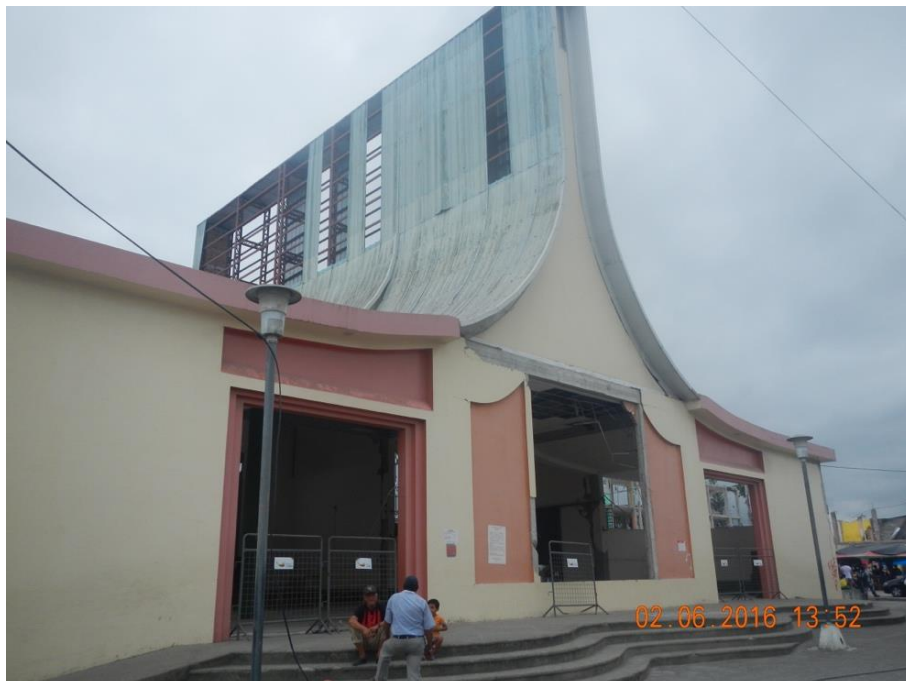
- Non-structural damage comprised in- and out-of-plane masonry infill wall damage.
- Detailed survey of the cathedral (Figure 10):
 - The cathedral is formed of RC and an architectural steel truss roof.

- Masonry was used throughout for infill, gable, and external walls.
 - Non-structural damage was heavy, with some significant masonry wall damage, and dislodged heavy ceiling tiles. Roof cladding panels had also fallen during the earthquake.

- Observed structural damage was light and appeared to be caused by connections to the masonry infill walls.

Figure 10 – Pedernales cathedral on Plaza Central

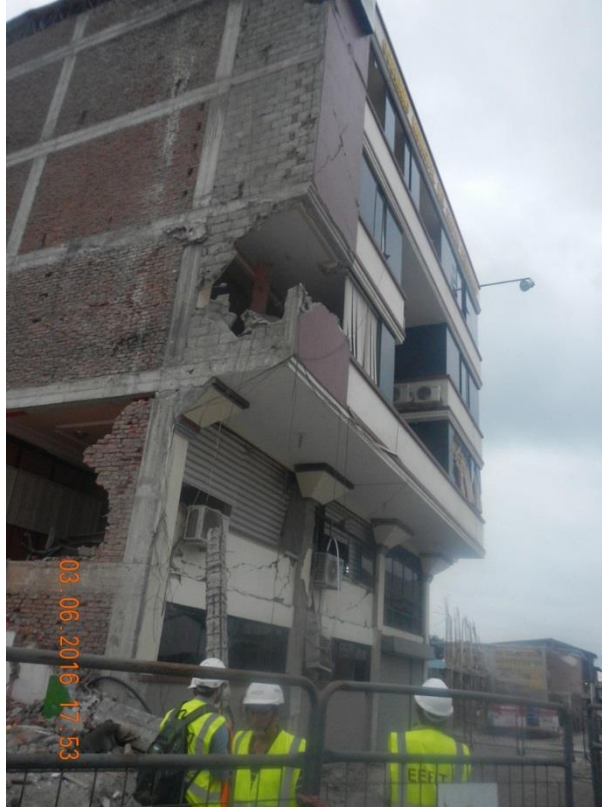
- Detailed survey of the main municipality building (Figure 11):
 - This building is a 5 storey building of RC frame construction with masonry infill internal and external walls.

- The team surveyed the building internally on level 1 and externally, and observed moderate structural damage, including cracks and spalling of concrete in the top of the columns, and heavy damage to the RC staircase.
- Non-structural damage was heavy with the failure of full wall panels internally and externally.

Figure 11 – The main municipality building in Pedernales

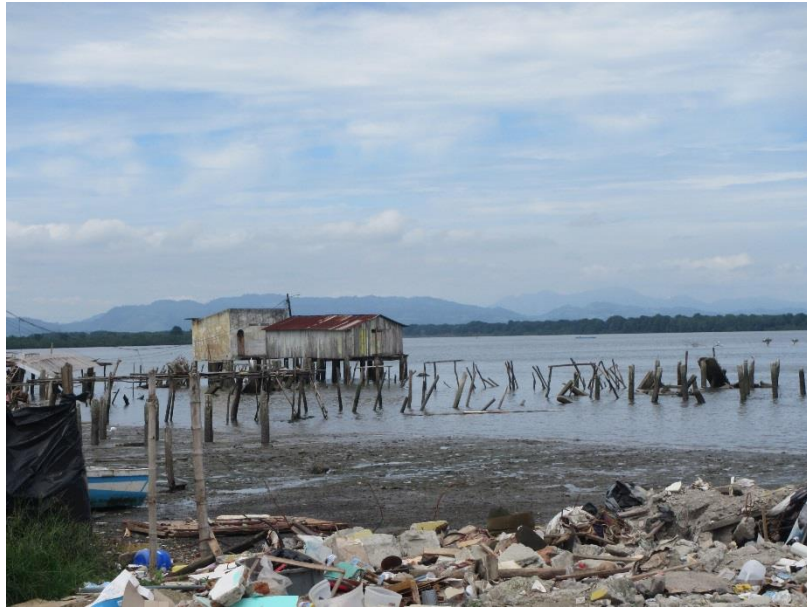
- Survey of village:
 - The village of Chamanga is mainly a low-income fishermen village. The mangroves once formed the coast line in Chamanga, but some of this area has been reclaimed for construction.
 - It was observed that there was a concentration of heavy damage in the buildings that were founded on the reclaimed areas along the coastline, with ground settlements suspected.
 - Some buildings are located just offshored, with timber and concrete piles used for foundations placed 1-1.5m deep (Figure 12). It is believed that there was no engineering behind any of those buildings.

Figure 12 – Buildings built near-shore in Chamanga founded on timber and concrete piles manually placed down to about 1-1.5m deep. The piles seen were previously used for one to three storey buildings.

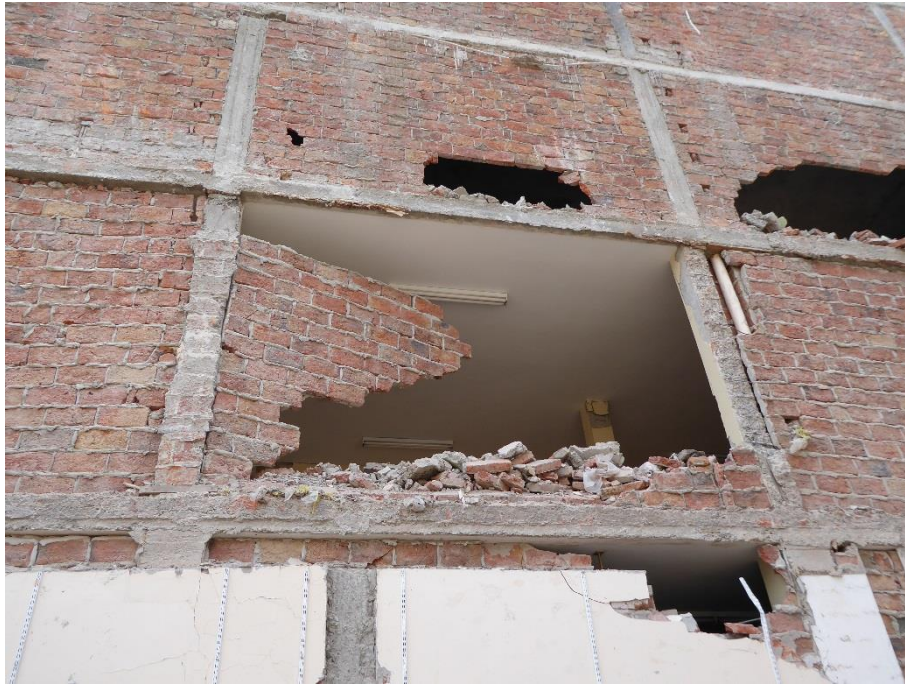
The masonry used to infill frames to provide facades and partition walls was inadequate in a number of areas (Figure 13):

1. The connections between the columns and the masonry were often insufficient – in many buildings no reinforcement bars existed connecting the two. This lack of a proper connection at the column interface can lead to the walls failing out-of-plane.

3. The aspect ratio of the panels was in nearly all cases too large for the thickness of the masonry, which means that the masonry is unable to arch under out-of-plane load, nor able to be stable under in-plane load, and can fail/buckle out-of-plane.

Inadequate masonry design and detailing was observed in many buildings that had infill masonry walls.

Figure 13 – Inadequate masonry infill wall design and construction

4. Where the designated lateral load-resisting system is a moment frame, the masonry should be decoupled from the frame through the introduction of a ‘soft’ joint on three sides of the masonry panel (typically 10-40mm thick), filled with a compressible material.

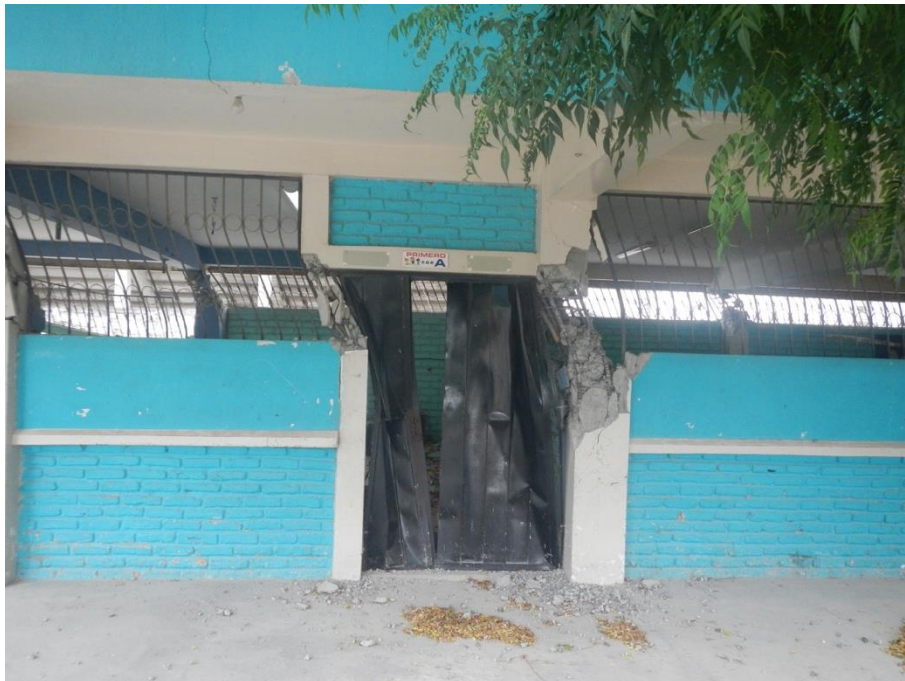
This failure occurs when partial height walls are constructed against columns. This construction promotes a brittle shear failure mode prior to a ductile flexural mode (Figure 14). This failure mode was seen in a number of buildings.

Figure 14 – Short columns at a school in Pedernales

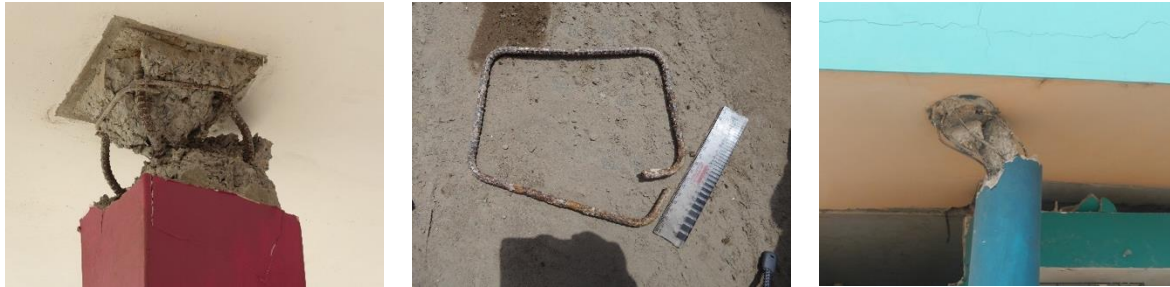
In seismic areas, the shear links within RC elements need special detailing. In particular, shear links need to be closely spaced, the two ends of the loop need to return into the column by an angle greater than 135 degrees, and the length of the returns need to be sufficient. This detailing ensures that the shear capacity of the concrete is as designed, helps to reduce buckling of the longitudinal bars and helps to confine the concrete in the core. In many RC buildings surveyed some or all of these detailing requirements were not present.

Figure 15 – Inadequate design and detailing for shear

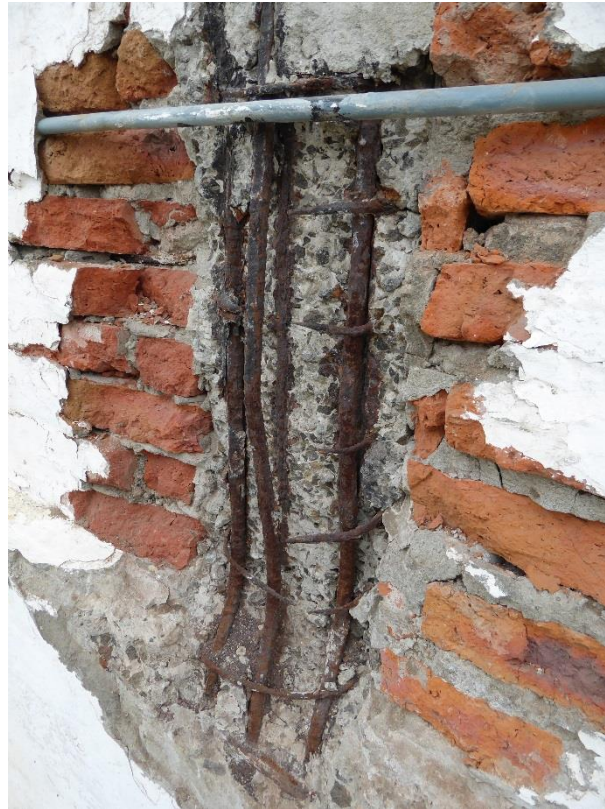
Sufficient cover to reinforcement is required to protect the reinforcement against corrosion. In coastal outdoor environments, the environment is more aggressive and the requirements for cover increase. In many columns the cover was very low (0-20mm), which caused corrosion to the steel. For comparison, for this region UK codes generally require around 50mm cover for good quality concrete in a coastal environment.

Figure 16 – Insufficient cover to rebar

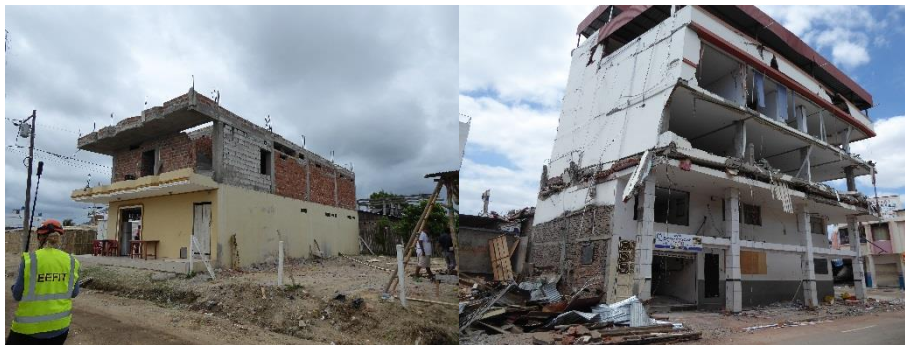
A number of buildings experienced upper floor soft storeys without a clear change in stiffness or strength. It is known that the reinforcement bars come in set lengths, and when placed for construction the top of the bars were often observed to rise just above the second floor. It is common to build just two storeys initially and leave extra reinforcement exposed, ready for an additional floor in the future (Figure 17).

In many cases, the amount of reinforcement sticking out may not be sufficient for a proper reinforcement lap, which would lead to a weak and brittle connection. In addition, the reinforcement bars are often left out for many years and so can experience surface corrosion, which can weaken their bond to the new concrete once poured. The combination of these

could lead to floors which are weaker when they line up with the inadequate column laps (Figure 17).

Figure 17 – Exposed reinforcement with possible inadequate lap lengths for future construction, and an upper storey soft storey failure

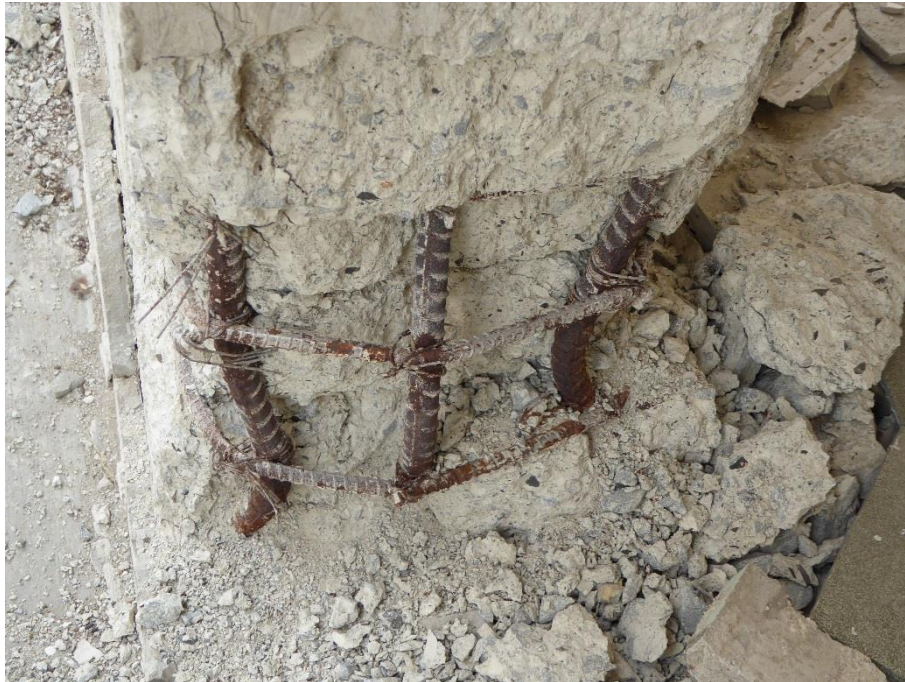
- Inadequate mix design – some concrete clearly had too much or too little coarse aggregate (Figure 18).
- Excess water – with informal construction, it is common to add excess water to the mix, which weakens the concrete.
- Poor compaction – some concrete clearly had not been properly compacted and voids was evident at the bottom of pours.

Figure 18 – Poor quality concrete

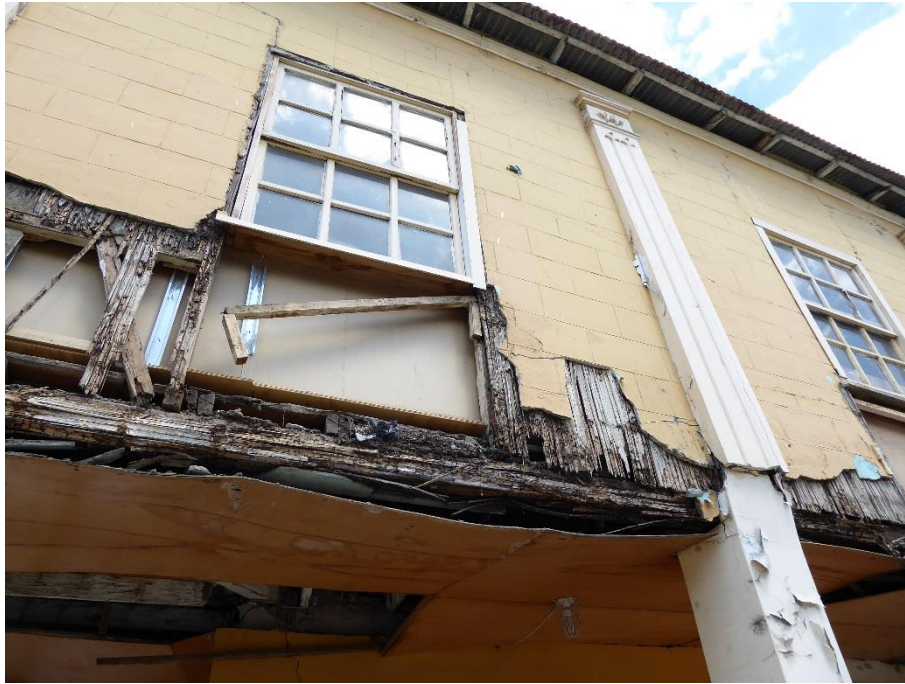
The majority of the damaged timber or bamboo buildings showed evidence of severe damage due to rot, termites or beetles, or a combination (Figure 19). This is due to:

- A lack of appropriate prior treatment of the materials.
- Inadequate selection of durable timbers.
- Inadequate design leading to large areas of the walls fully exposed to the elements.
- A general lack of maintenance, including replacing damaged elements and painting.
- The encasing of timber or bamboo within concrete as a connection to the foundation.

Figure 19 – Rot and damage due to insects
