Investigation of damage to buildings and ground truth verification for satellite data in Kathmandu Valley due to the 2015 Gorkha Earthquake

Tsuneo OHSUMI

Principal Research Fellow, Disaster Risk Unit,
National Research Institute for Earth Science and Disaster Prevention (NIED), Japan
t_ohsumi@bosai.go.jp

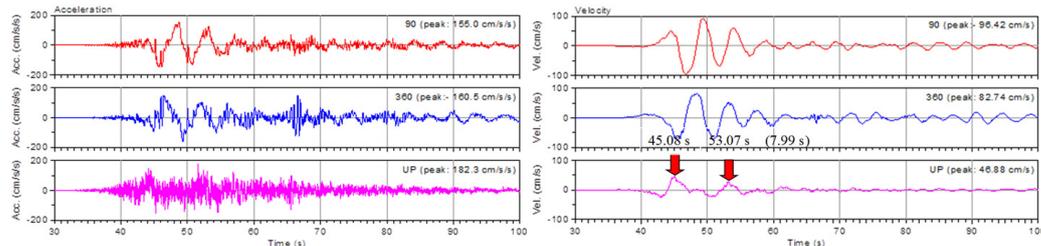
Figure 2.1 shows the three components of acceleration and velocity recorded by the CESMD station at the US Embassy in Kathmandu, which recorded the M_w 7.8 main shock (06:11:26 UTC, 28.15°N 84.71°E, 15.0 km deep). **Figure 2.2** shows the three components of the tripartite response spectrum of the main shock and aftershocks. The dominant periods in the Fourier spectra were approximately in the range of 4 to 5 s for magnitude 7 class events. However, for magnitude 5 class events, the dominant periods of the Fourier spectra were about 0.5 s. The response spectrum of the pseudo velocity exceeds the 400 cm/s level of the response spectra in the case of the main shock.

In **Figure 2.1**, the vertical velocity motion waveform has two pulse-like ground motions. The main parts of the velocity waveform can be seen centered at two points: 45.08 and 53.07 s. The difference between the rupture start time and arrival time for the S-wave is 8 s. The dominant period of the body wave is about 4 s.

Figure 2.1: Acceleration (left) and Velocity (light) Record of M_w 7.8 main shock

These sizes can be estimated for each strong motion generation area (SMGA) by direct interpretation of body waves.

Thus, two SMGA might exist near the city of Kathmandu.

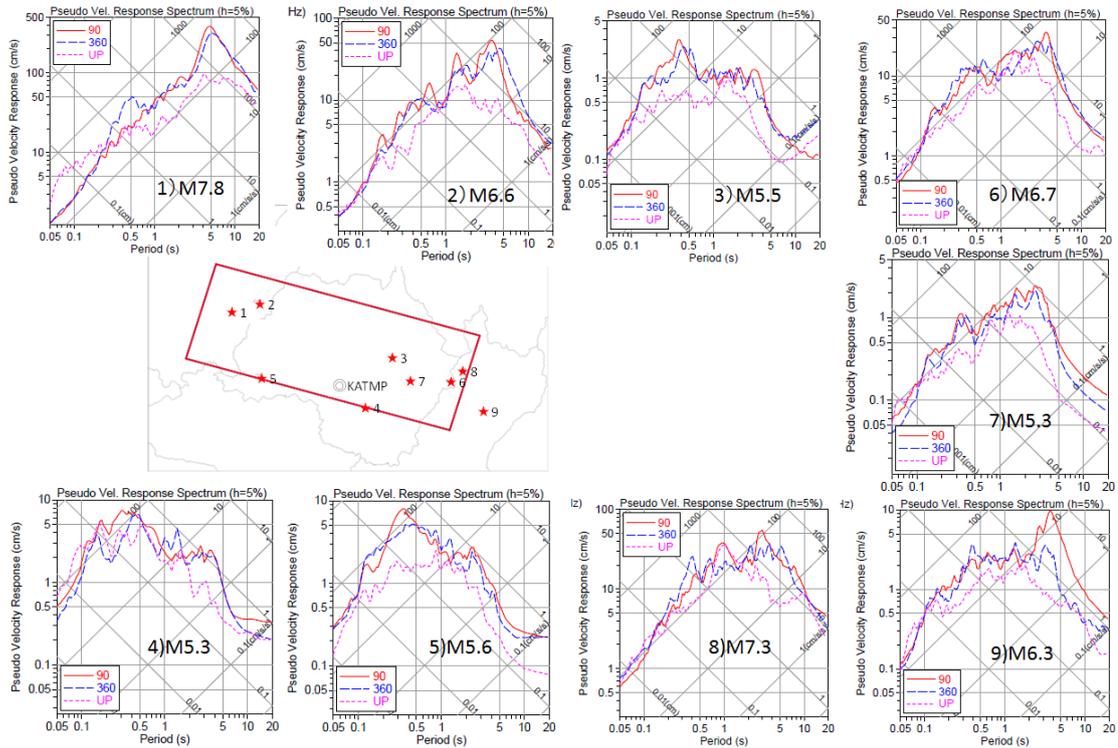
Figure 2.2: Response Spectrum of main shock and Aftershocks.

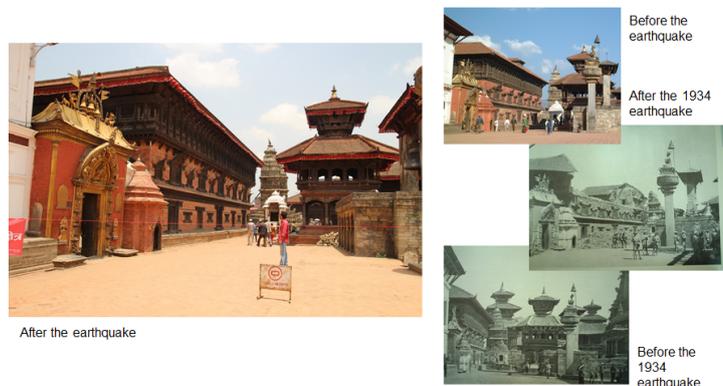
“*Bhakta*” means Devotee in Sanskrit, and pur means city. Thus, “*Bhaktapur*” is the city of devotees. The central areas of these palaces are referred to as “*Durbar Squares*”. Bhaktapur’s Durbar Square is a conglomeration of pagodas, and during the earthquake series, many Sikhara style temples in Bhaktapur’s Durbar Square were severely damaged (**Figure 3.1**).

Figure 3.1: Bhaktapur before / after the earthquake (Photo. by T. Ohsumi), before / after the 1934 earthquake in Bhaktapur (Courtesy of MoHA)

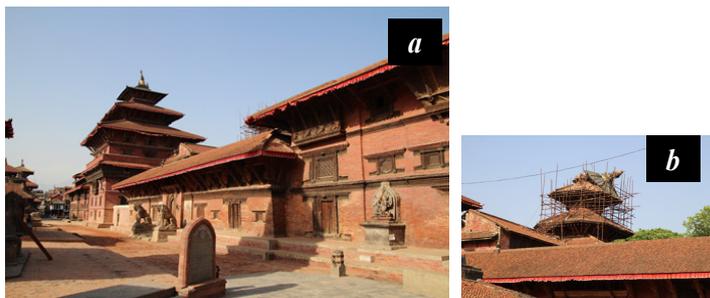
Thus, the palace had only partial damage during the earthquake at the top of structural parts of the buildings (Gajur and Baymvah) (**Figure 3.2**).

Figure 3.2: In Patan, after the earthquake, this place (a) had partial damage at top of structure parts (Gajur and Baymvah) (b) (Photo. by T. Ohsumi).

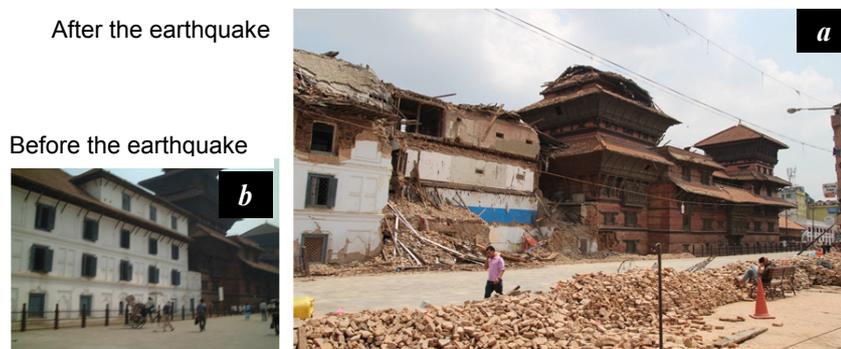
The old palace structures in Kathmandu’s Durbar Square, which had not undergone renovations, had severe damage during the earthquakes (**Figure 3.3**). In the photo on the left, the white structure is about 150 years old, built during the Rana Dynasty. In the photo on the right side, the four-tiered brown temple is about 300 years old, constructed during the Gorkha Dynasty.

Figure 3.3: Kathmandu Durbar Square after the earthquake (a), before the earthquake (b) (Photo. by T. Ohsumi)

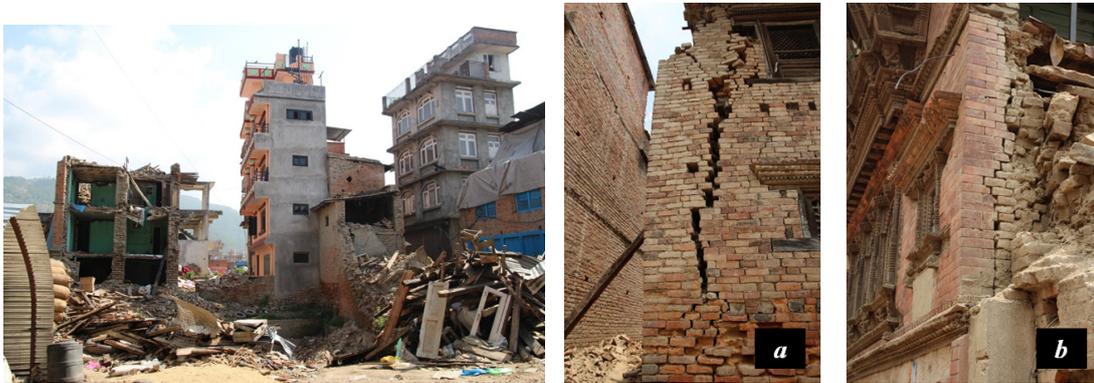
The difference in damage as a result of building type was remarkable. Damage in Sankhu was extensive. Brick and cement mortar houses without RC columns experienced a lot of damage. In contrast, the damage to RC structures – particularly those erected in recent years – was generally minor. These structures were mainly five

to six story buildings. In contrast, many of the non-engineered masonry structures that experienced complete collapse or partial damage were two to four story buildings in Sankhu (**Figure 3.4:left**). Damage in non-engineered masonry structures was initiated by vertical cracks in the corners of the buildings (**Figure 3.4:a**), which contained no RC columns (**Figure 3.4:b**). The outer wall structures of such buildings was generally burned brick with cement mortar joints to withstand rain. In several cases, the inner walls of buildings are adobe bricks with mud mortar.

Figure 3.4: The damage to RC structures was generally minor. These structures were mainly five to six story buildings. Many of the non-engineered masonry structures that experienced complete collapse or partial damage were two to four story buildings in Sankhu (left). Damage in non-engineered masonry structures was initiated by vertical cracks in the corners of the buildings (a), which contained no RC columns (b).

- 1) Although RC buildings were partially damaged, the difference in damage between buildings with and without RC appears remarkable. Brick and cement mortar houses without RC columns generally had a lot of damage. Structures having no RC columns in the corners generally experienced vertical cracking in the brick masonry walls.

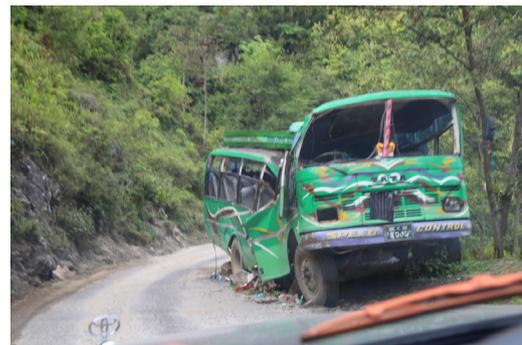
A numerous number of huge slope failures which occurred in the mountainous area buried villages and valleys, and resulted in the loss of many lives. We visited a landslide zone in Ramche, and it is located in the northwest of Kathmandu city in a mountainous area. Many of fallen rocks were on the roads, also we encountered a bus that hit by falling rocks (**Figure 4.1**). Thick talus is deposited in the landslide area in Ramche, in Rasuwa district (**Figure 4.2**). The town is located at an altitude of 2,068 m. There are houses that had been caught in a landslide, but the damage was limited. However, the whole scope of the slope failures is not clear at the present time, because any detailed and total survey in the mountainous area has not been carried out. Thus, casualties will increase as they are found.

Figure 4.1: Bus was hit in falling rocks in Dhikure, on Baglung Rajmara Highway.

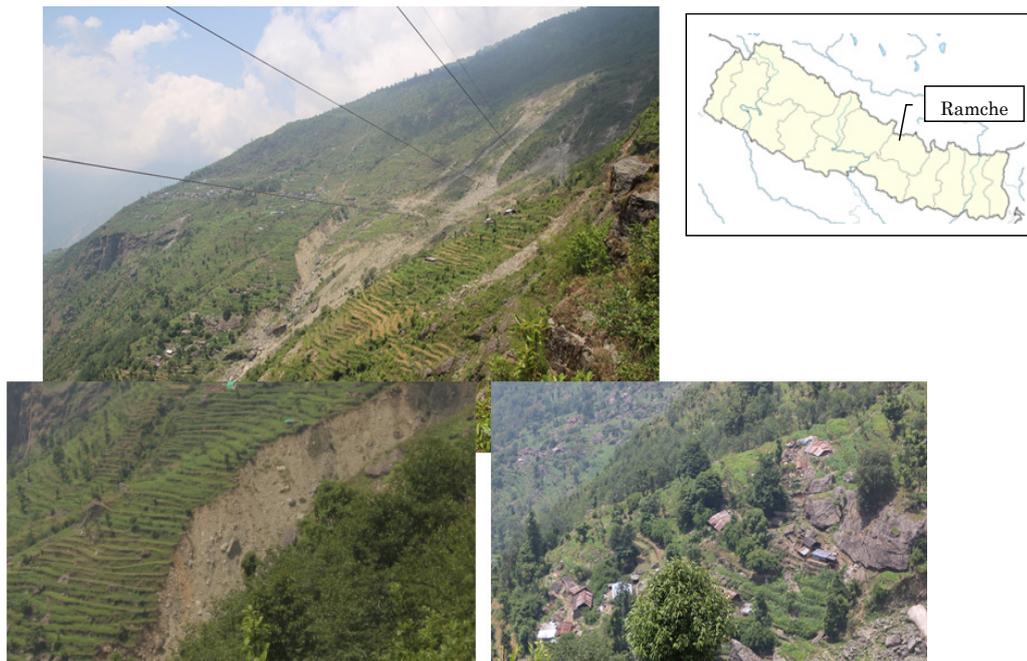
Figure 4.2: Thick talus is deposited in the landslide area in Ramche.
(Photo. by T. Ohsumi)

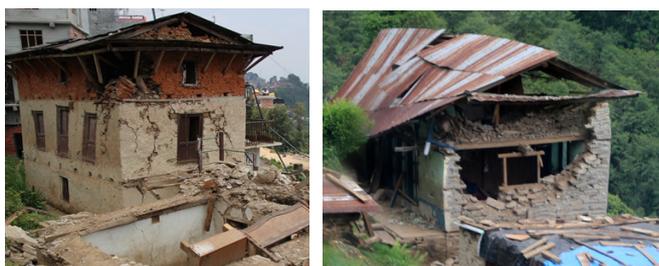
Urban and rural housing is significantly different. In the suburban and rural areas where there are many stone houses, a lot of damage occurred. The collapse of heavy stones used in house construction, resulted directly in deaths and property destruction.

In Dolakha district, adobe style houses collapsed. Primarily, adobe houses collapsed as a result of cracks in the gables and corner foundations as a result of ground motion. Many adobe style houses were broken at their gables. Stone houses could also collapse as a result of delamination (**Figure 5**).

Figure 5: Adobe style houses (*left*) and Stone style house (*right*) in Charikot, (Photo. by T. Ohsumi)

- 4) In rural areas, stone masonry is used as a current building technique. Retrofitting such low-cost non-engineered housing is a key issue.
- 5) The dominant periods observed in the Fourier spectra of magnitude 7 class events are approximately 4 to 5 s. However, for magnitude 5 class events, the dominant periods are much shorter 0.5 s. These differences in shaking periods / frequencies can have a significant effect on the resulting damage.
