Addendum on Structural Damages (August 2016)

This addendum to the paper to be published at the 16th World Conference on Earthquake Engineering provides further descriptions on structural damages. **A FINAL REPORT including all updated observations and analyses will be published during the fourth quarter of 2016.**

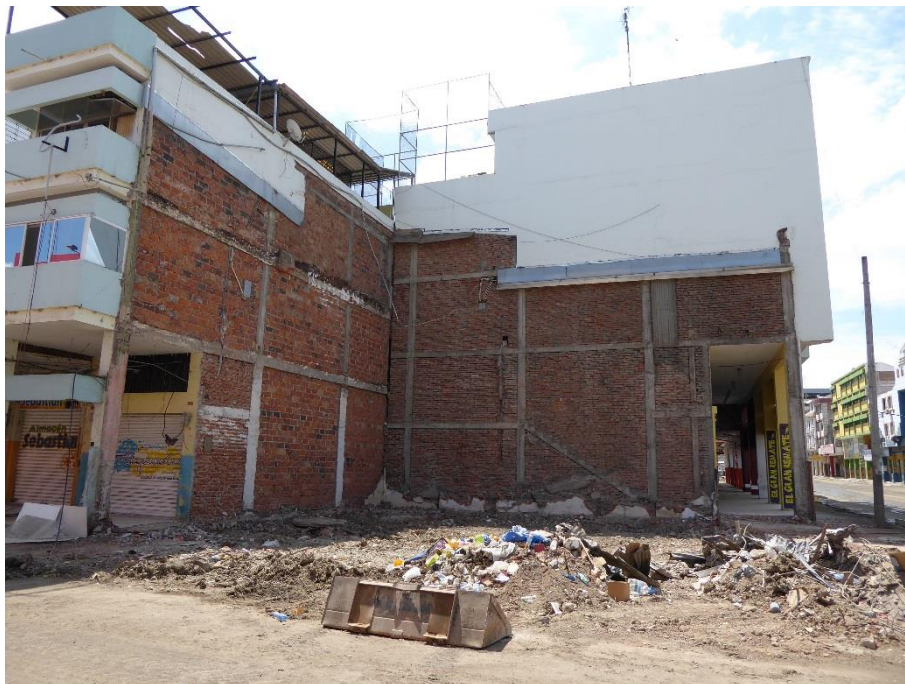
This is the most common building typology observed in the affected region (Figure 1). It consists of reinforced concrete (RC) columns and slabs (sometimes with beams), with masonry walls forming the façade and internal partition walls. In some cases, reinforcement bars connect the masonry to the concrete structure. The masonry panels tend to be very slender. In reality, the lateral load-resisting system will be a combination of RC frame action and the masonry infill walls. The design and construction of these systems varies greatly in quality, with some frames clearly having been engineered for gravity loads, while the majority are likely to be non-engineered and built by local builders.

Figure 1 – Reinforced concrete structure with masonry infill walls

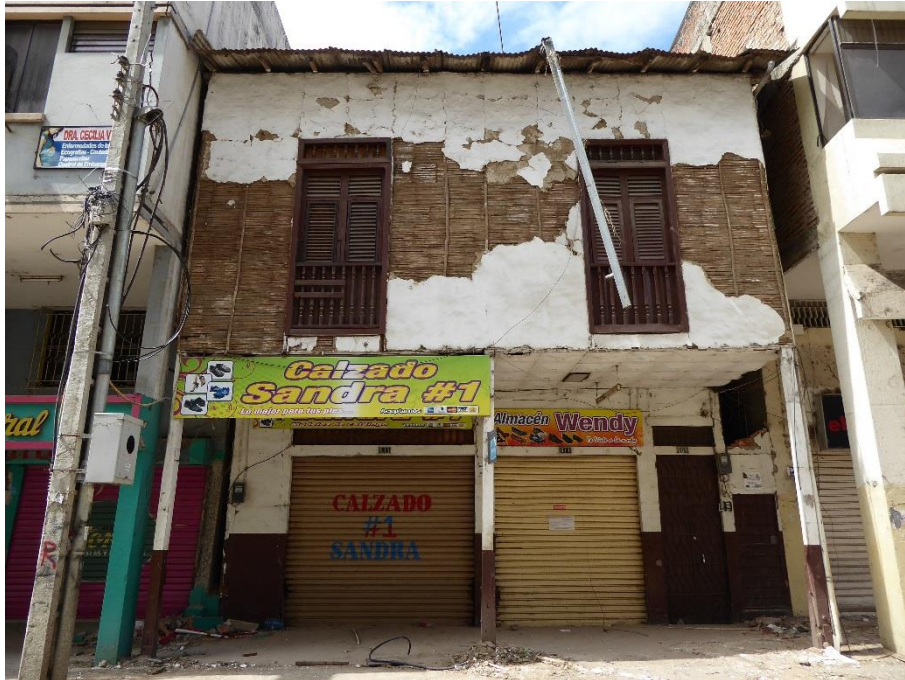
Quincha/bahareque is a derivative of wattle-and-daub popular in Latin America (Figure 2). *Quincha* in the areas surveyed typically consists of a timber frame, clad in a matrix of split bamboo, plastered in manure or soil, sometimes with straw or horse hair added for strength. This structural system is primarily used for one or two storey structures, with the floor and roofing system constructed from timber. It is very common to see the ground floor used for retail with an overhang, while the upper floor may be residential or used for storage. Properly constructed and maintained *quincha* has been shown to possess good structural unity and

flexibility, and thus can behave well in earthquake shaking. However, it requires a reasonable standard of construction, detailing and maintenance to avoid deterioration through rot or insect attack. The *quincha* structures observed tended to be quite old, often showing serious signs of rot and insect (especially termite) attack.

Figure 2 – Quincha structure

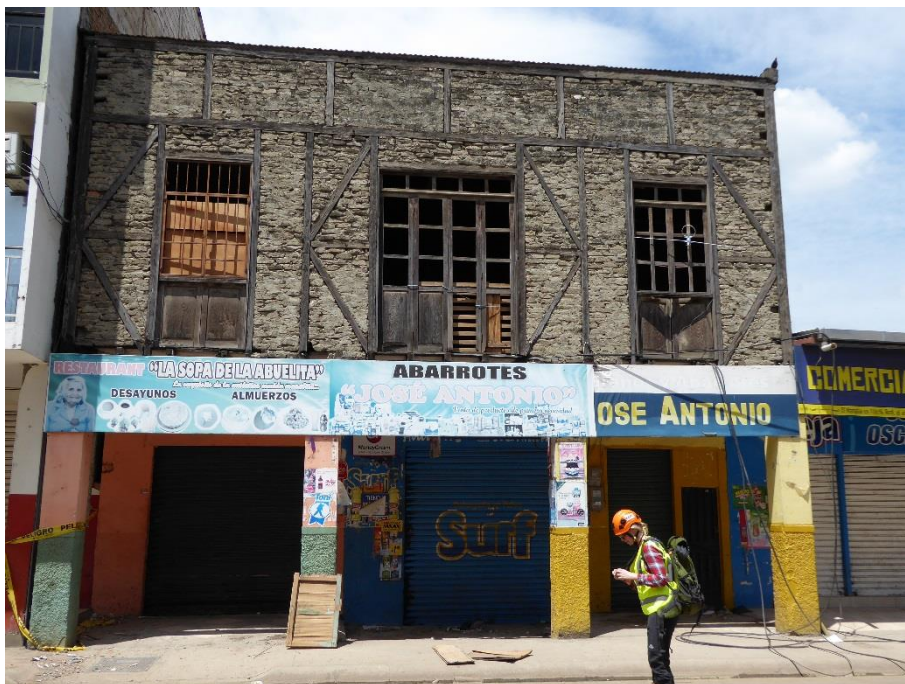
Figure 3 – Timber frame with masonry infill

concrete block) or had a timber or CGI sheet façade (Figure 3). In some cases this system was combined with quincha or RC frame with masonry infill, with the heavier system on the ground floor and the lighter system on the first floor. Maintenance of these buildings is essential, and many of these structures showed signs of insect attack and rot.

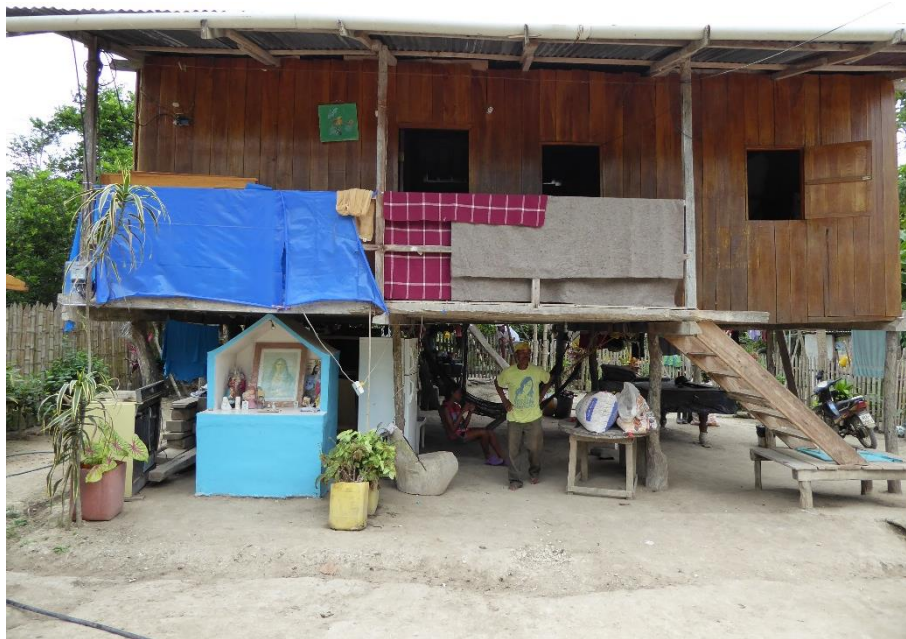
Informal housing in rural areas generally uses either timber and/or bamboo for the frame (Figure 4) or RC frames with masonry infill. These systems are completely non-engineered and vary significantly in their ad-hoc stability.

Figure 4 – Informal rural housing
