Cyclone-resistant houses for developing countries

Alan Mayo

Building Research Station

This publication is a review of the work carried out overseas by the Building Research Establishment on the effects of wind on buildings. It draws together the results of studies made in various developing countries to provide information which is applicable throughout the world.

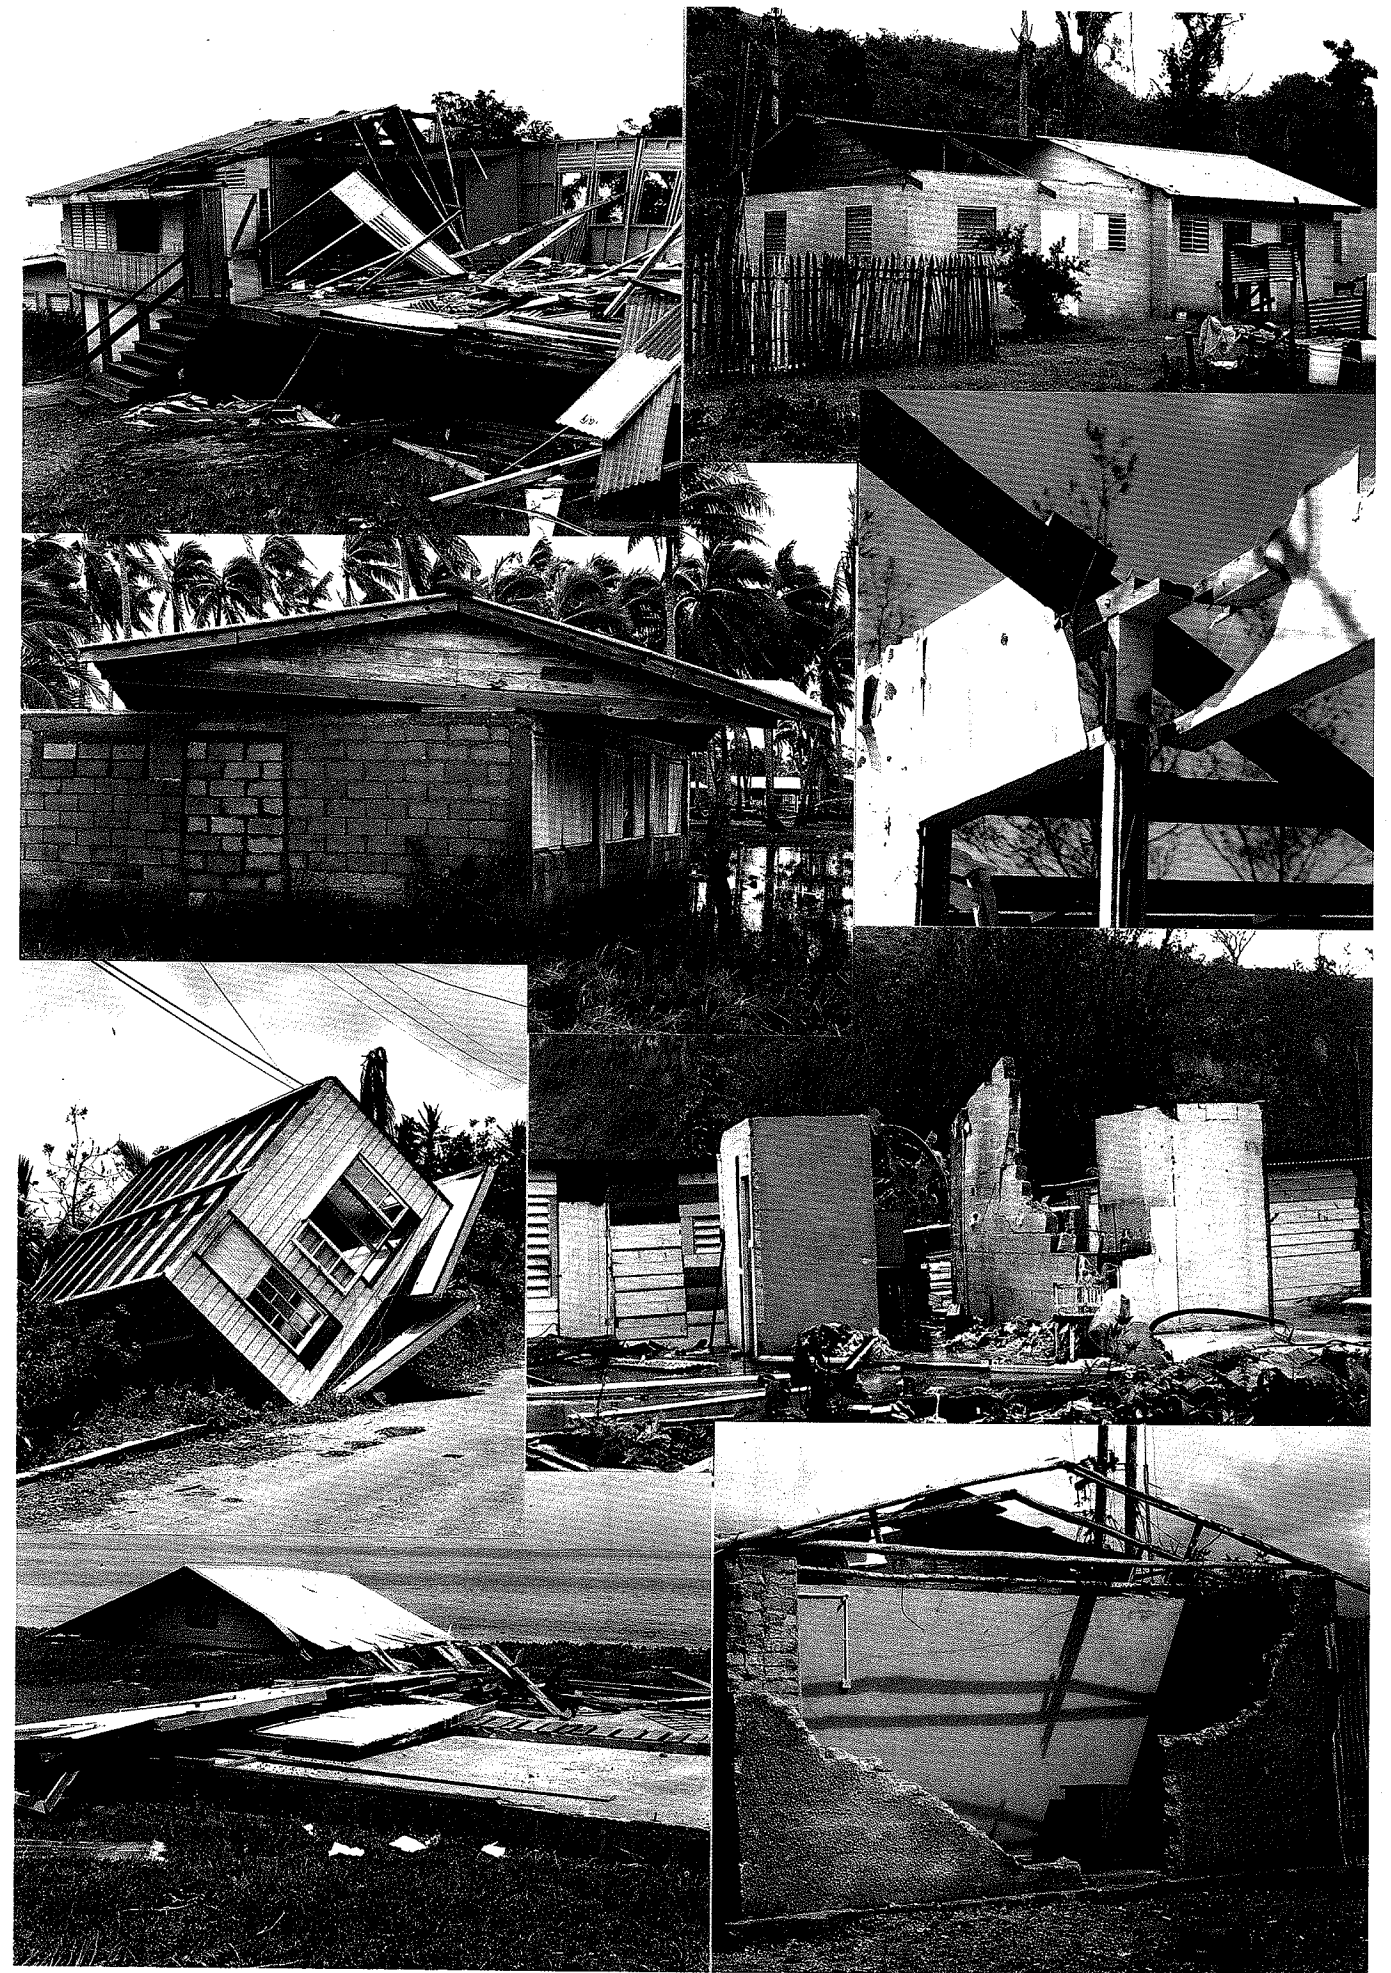
Figure 2 Examples of damage to buildings by cyclones

Cyclones originate over tropical oceans and seas when air is still and the water warm. These conditions can exist for lengthy periods during late summer in six main areas of the world¹ (Figure 1). Many cyclones dissipate at sea but those which come ashore can cause serious damage to buildings (Figure 2) resulting in many people being made homeless as well as causing injury and loss of life.

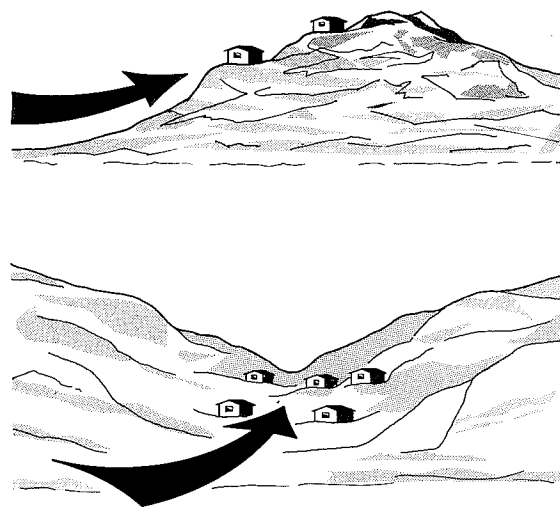
Figure 3 Hills and open-ended valleys increase wind speeds

Topography is an important factor influencing wind speeds, particularly near the tops of hills and along the bottoms of open-ended valleys where increases in wind speed of between 10 and 20% are common (Figure 3).

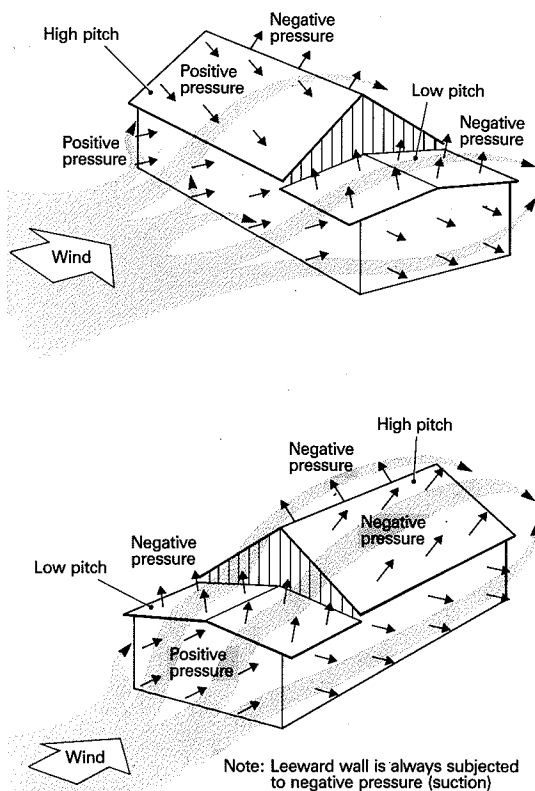
Figure 4 Wind forces on walls and roofs of buildings are affected by direction of wind and shape of buildings

The forces exerted by the wind on the walls and roof of a building are governed not only by the wind speed, but also by the shape of the building and the direction of the wind relative to the building (Figure 4).

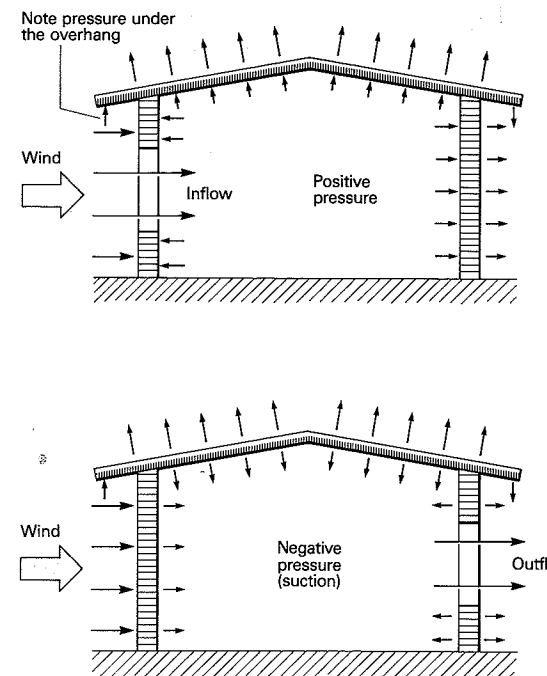
Figure 5 The effect of openings in windward and leeward faces

The total wind force on a wall or roof depends on the difference between the pressures on the inner and outer faces of the wall or roof. Open doors, windows and ventilators on the windward side of a building cause the air pressure to increase inside the building. This has the effect of increasing the total force on those elements of the building which experience external negative pressures, and reducing the total force on those elements subjected to external positive pressures (Figure 5).

Conversely, openings in walls in the lee or parallel to the wind direction cause a reduction in air pressure inside the building. This increases the total force on the windward wall and counteracts the external negative pressures on the remaining walls and the roof.

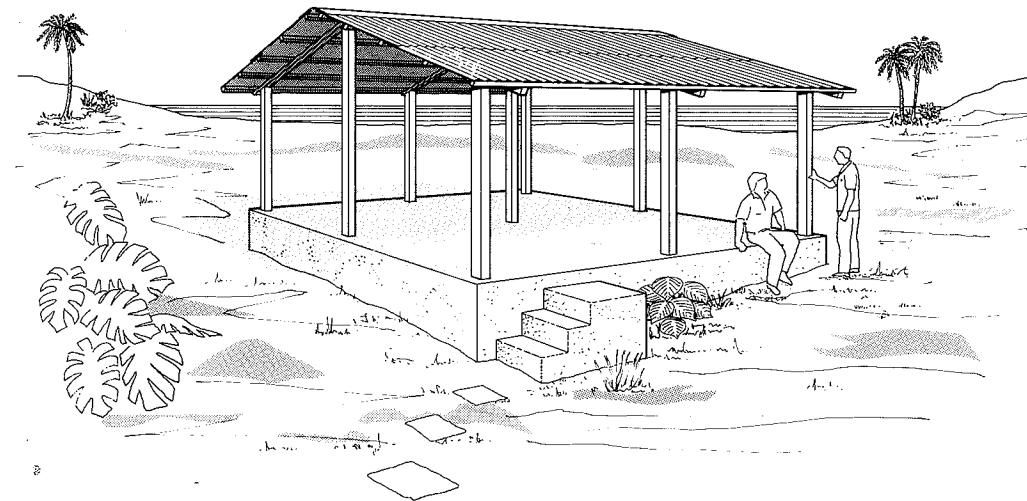
Figure 6 Building Research Establishment/Housing & Land Development Corporation St Vincent low-income house (type 1) — 45 square metres

House 1 (Figure 6) is 7.3 m × 6.1 m in plan with a solid concrete floor. The hardwood columns, beams, rafters and purlins are interconnected with rigid brackets and the roof clad with 'Onduline', a corrugated bitumen-fibre sheeting.

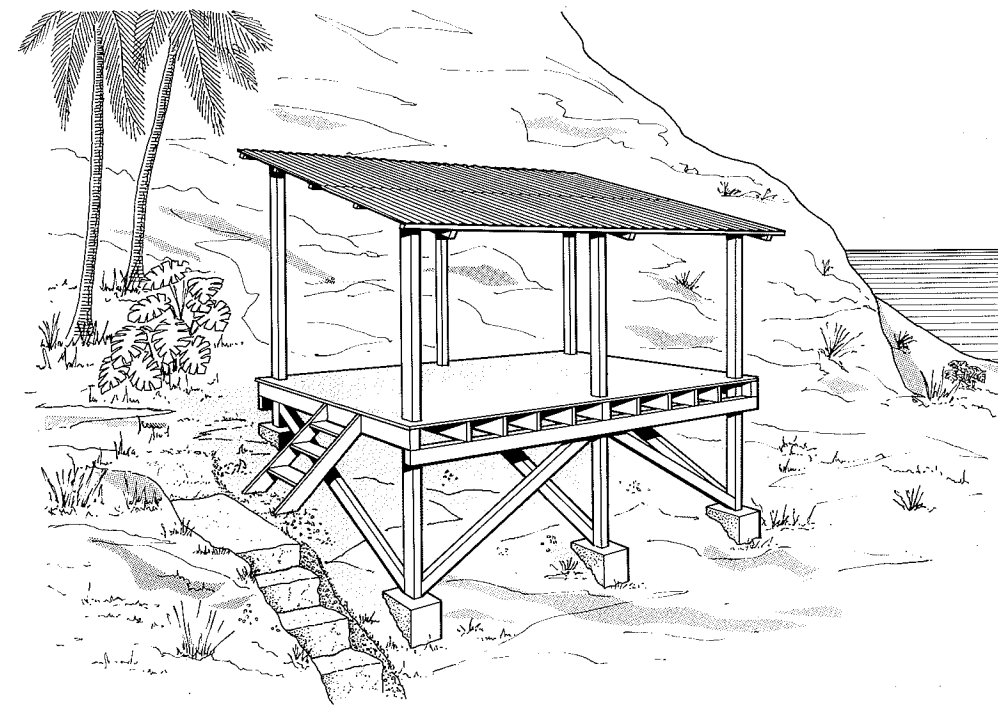
Figure 7 BRE-HLDC St Vincent low-income house (type 2) — 19 square metres

House 2 (Figure 7) is 6.1 m × 3.0 m in plan with a hardwood substructure and floor. Again, the hardwood columns, beams, rafters and purlins are all inter-connected with rigid brackets and the roof clad with 'Onduline' sheeting.

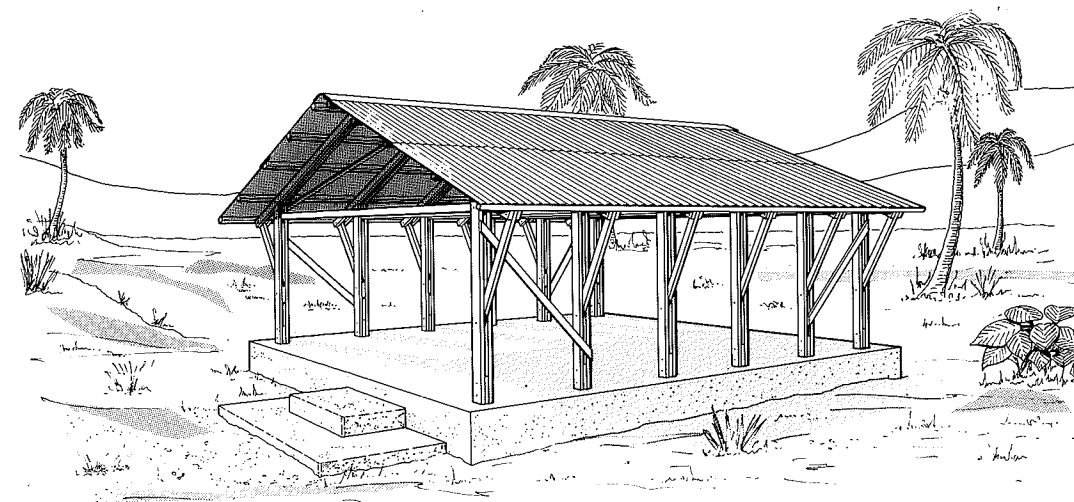
Figure 8 BRE-HLDC St Vincent low-income house/community building — 51 square metres

House 3 (Figure 8) is 7.3 m × 6.1 m in plan with a solid concrete floor. It has reinforced hollow-concrete block columns with a hardwood ring-beam, trusses and purlins, all rigidly interconnected and supporting 'Onduline' roof sheeting.

Subsequently, a fourth design was developed and a trial house constructed (Figures 8 and 9). The main features of this design are the structural strength, ie resistance to earthquakes and hurricanes; the low cost and ease of construction — permitting considerable prefabrication with the frames assembled in a jig; the use of single-size timber (50 × 100 mm) and single-size bolted joints throughout; a wide clear span up to 6.1 m, and unlimited length providing a building capable of many uses from single-family housing to community buildings such as schools and medical centres.

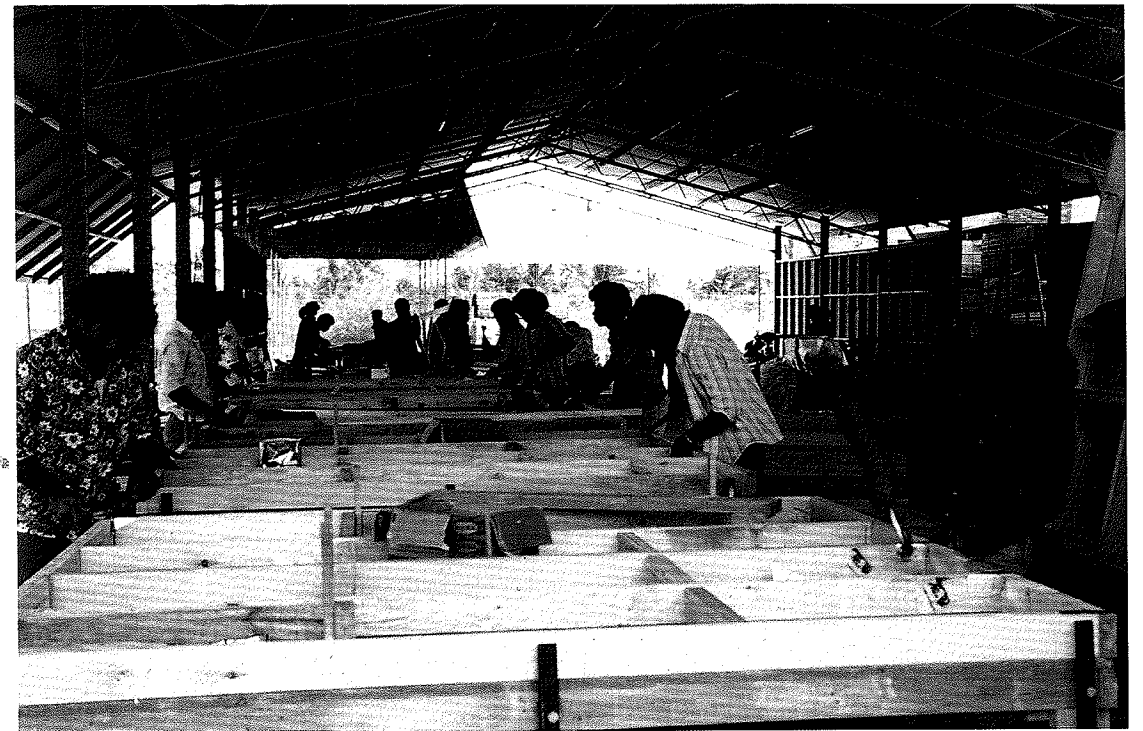
Figure 11 Factory prefabrication of Tongan housing

Figure 12 Factory prefabrication of Tongan housing

Following the devastation caused on islands of the Kingdom of Tonga by cyclone 'Isaac' in March 1982, a major house-building programme was undertaken using timber frame construction methods with the panels prefabricated under factory conditions (Figures 11 and 12).

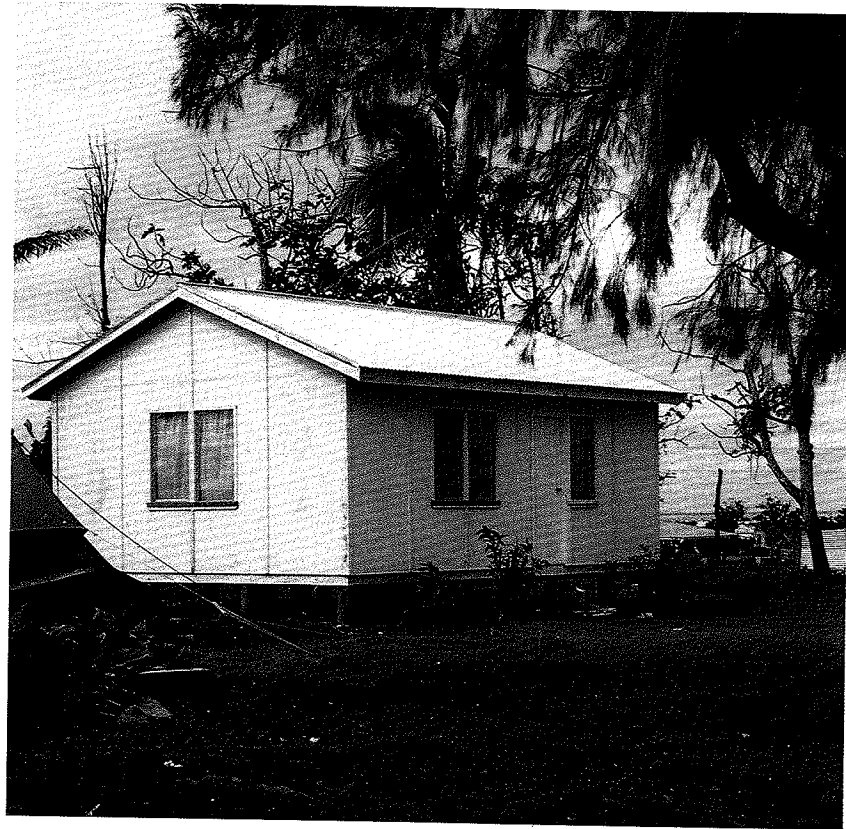
Figure 14 Basic Tongan house with suspended timber floor on timber piles cast in concrete footings

The design was developed jointly by the Tongan Ministry of Works and BRE with specialised advice provided by the Cyclone Testing Station in Townsville, Queensland¹³. The walls were formed with modular panels 2.4 m long, fabricated with 50 × 100 mm studs at 600 mm centres and sheathed with plywood or fibre cement boards. The roofs were constructed with timber trusses jointed with plywood gussets or hammer-in type metal tooth plates, and clad with corrugated galvanised steel sheets. Proprietary steel straps (framing anchors) were used to fix the roof purlins to the trusses, and the trusses to the wall panels (Figure 13). Examples of the finished houses are shown in Figures 14 and 15.

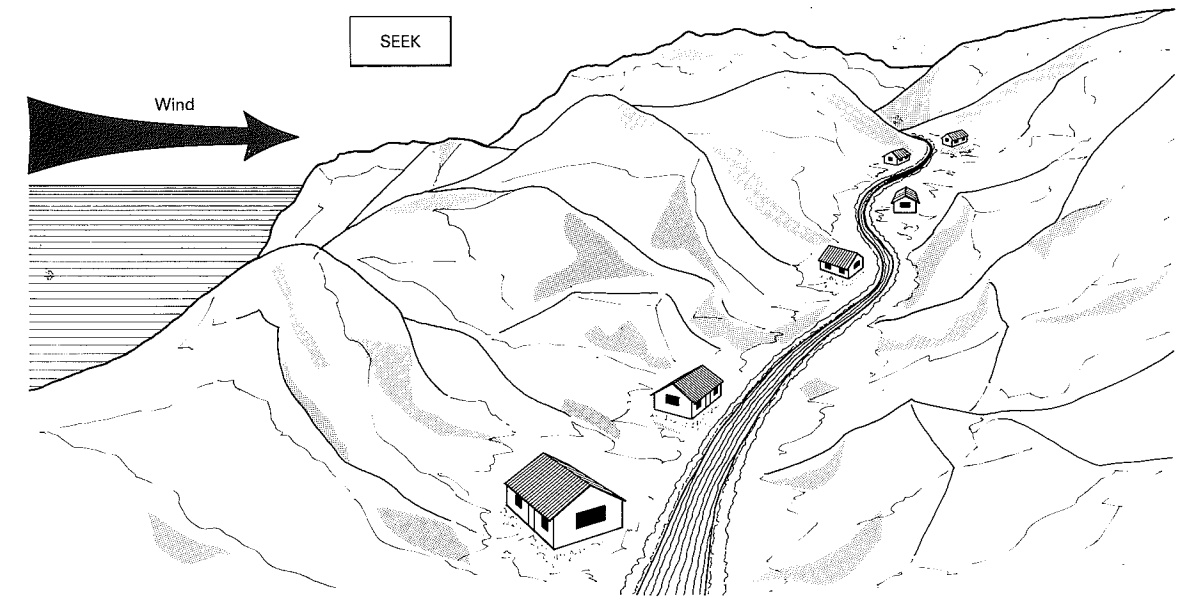
Site buildings in groups' making use of natural vegetation to provide limited but significant wind breaks.

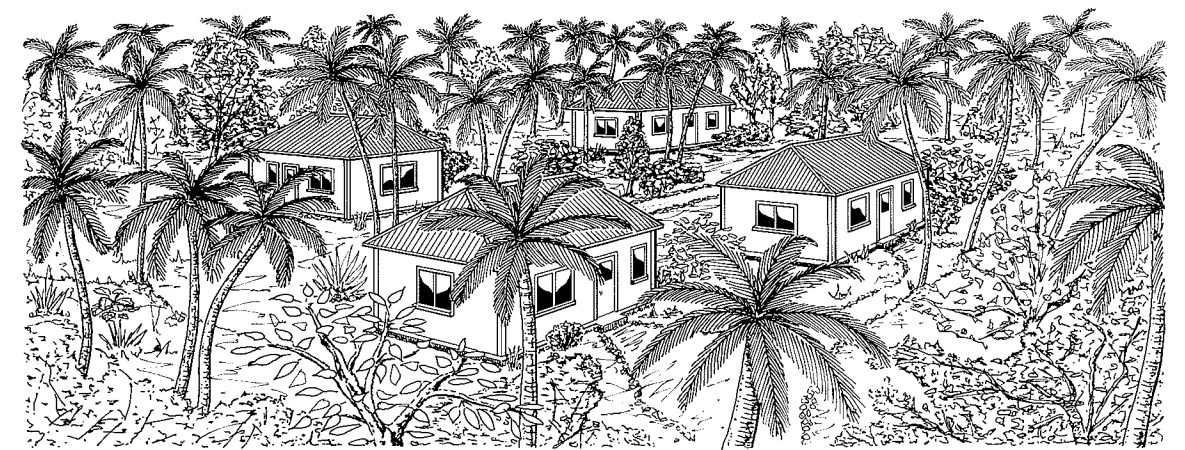
Shape. To reduce the uplift forces, build roofs with pitches between 30° and 40° and if possible provide high-level ventilation at the ridge. When possible, use hipped ends rather than gable ends.

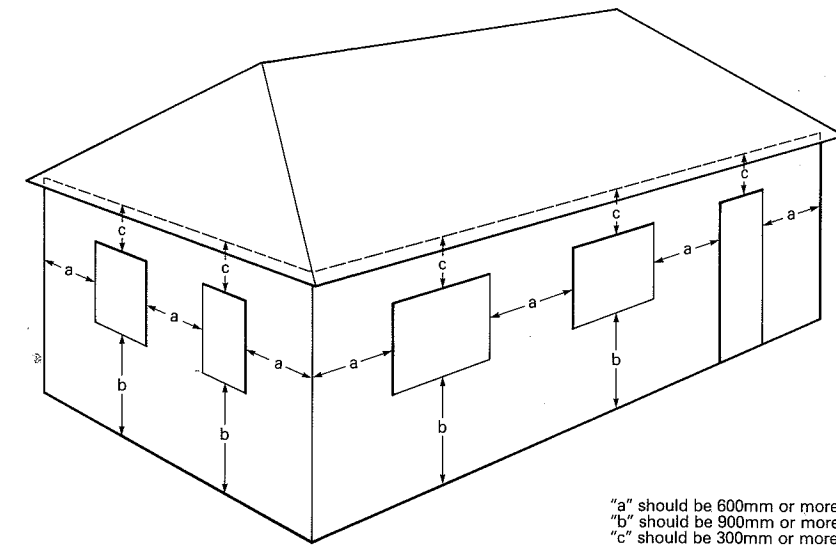
For each wall, the sum of the lengths of wall between openings (ie dimension 'a' should be not less than half the overall length of the wall.

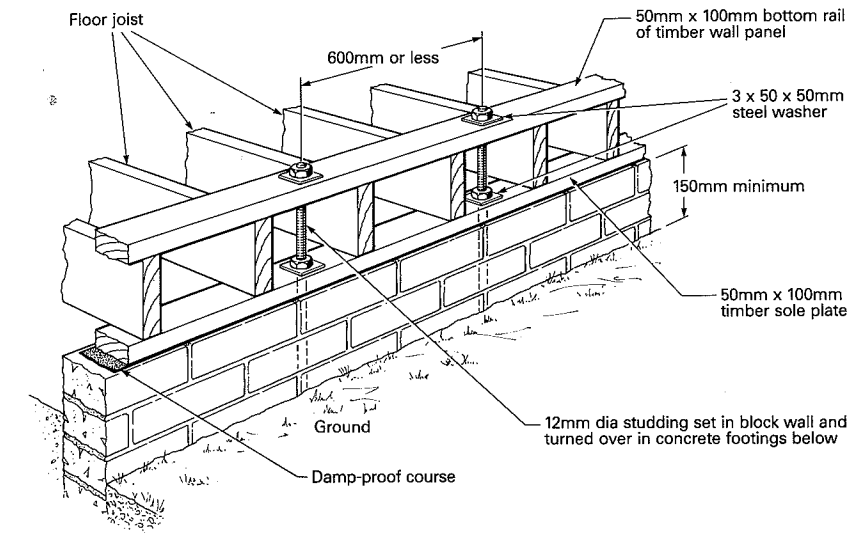
- (2) by fixing to the wall plate with metal framing anchors or galvanised metal straps.

NOTE: Make sure the wall plate is firmly fixed to the foundations.

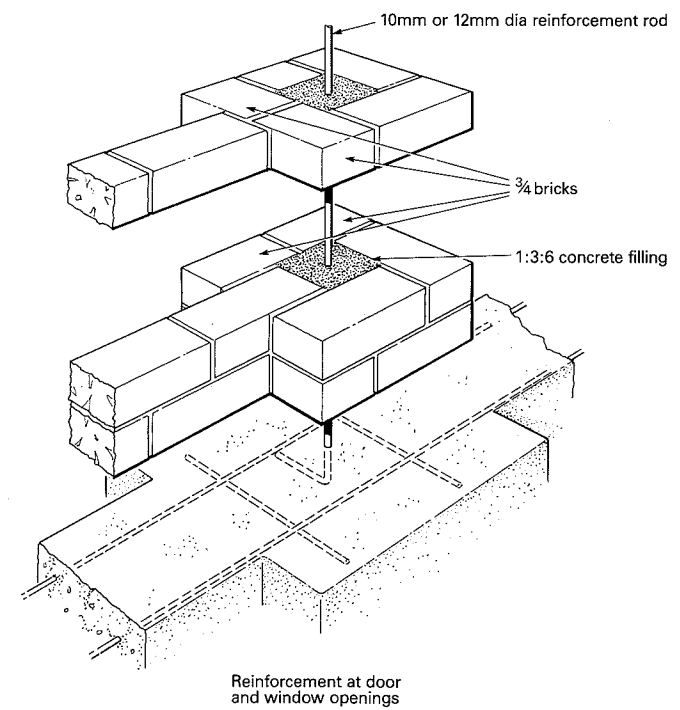
Walls. All masonry walls must be reinforced at all corners and junctions as well as at the sides of the doors and window openings. On long walls without junctions or openings, reinforced sections should be constructed at intervals of not more than 1.2 m for hollow block walls and not more than 2.0 m for solid block walls.

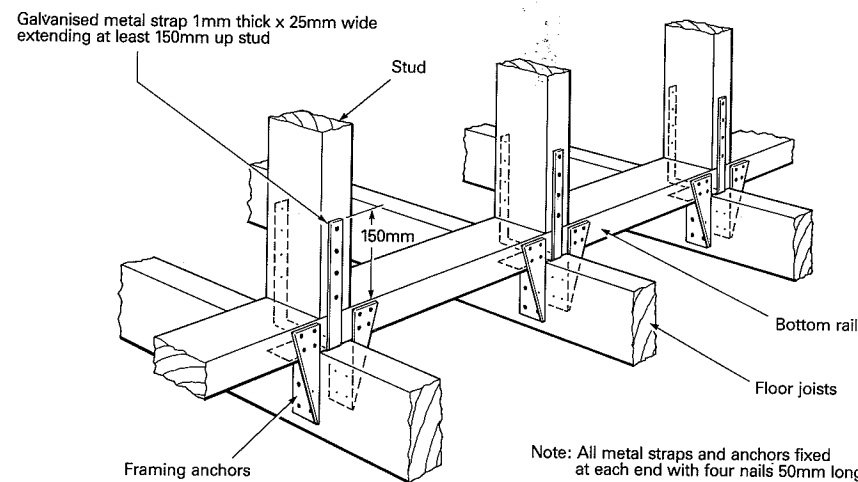
Note: All metal straps and anchors fixed at each end with four nails 50mm long

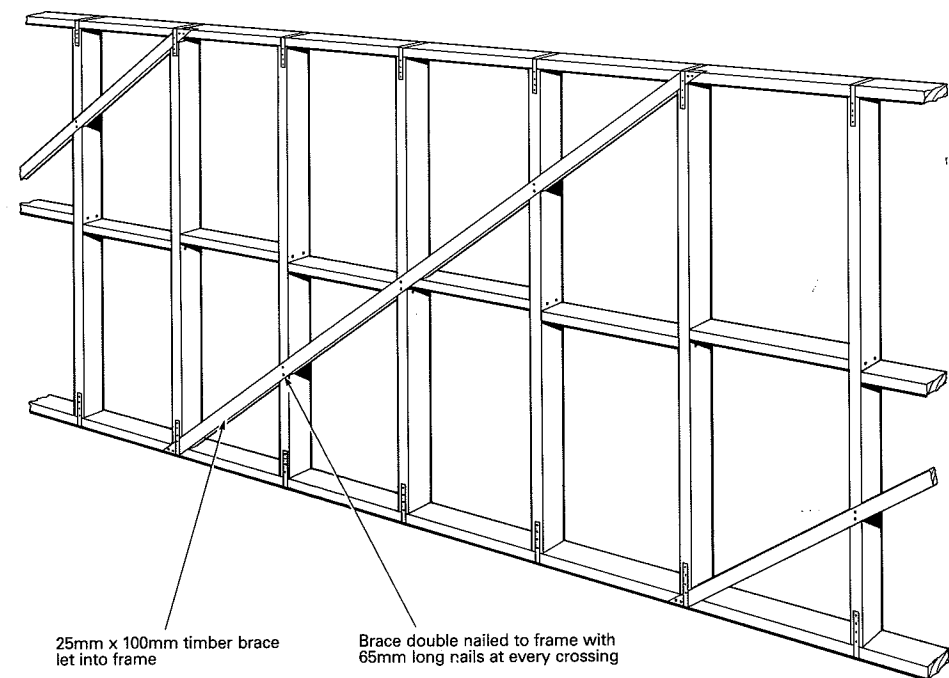
Unless timber-framed walls are fully sheathed with well nailed rigid boarding such as plywood or similar, they should be fitted with diagonal timber braces let into the framing.

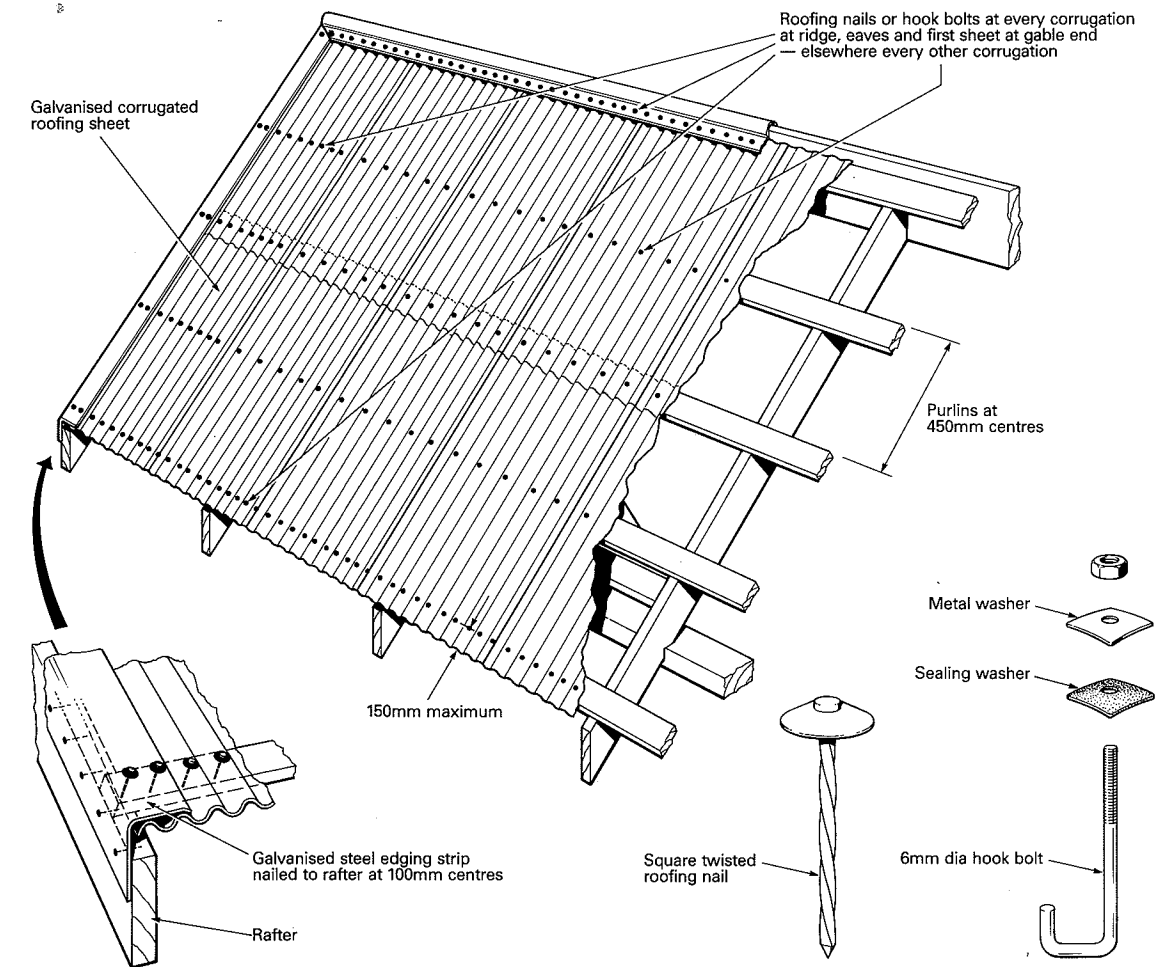
Where lightweight corrugated roofing sheets are used to cover a roof, every sheet should be securely fixed down to the purlins with galvanised hook bolts or special square twisted roofing nails. Particular attention should be given to the edges of a roof where wind uplift forces are greatest and fixings should be more frequent to prevent roofing sheets being 'peeled back'.

- (4) Fixings for lightweight roof sheeting should be checked to see if they have vibrated loose, particularly round the edges of the roof and at the ridge.
